Uniform Mitigation Verification Inspection Form

Inspection Date: 11/17/2022		
Owner Information		
Owner Name: Gulf Winds Condominium East Association		Contact Person: Brett (PM)
Address: 1004 Manatee Road		Home Phone:
City: Naples	Zip: 34114	Work Phone:
County: COLLIER		Cell Phone: 239-326-6342
Insurance Company:		Policy #:
Year of Home: 1984	# of Stories: 3	Email:

Gulf Winds Condominium East: 1004 Manatee Rd Built 1984

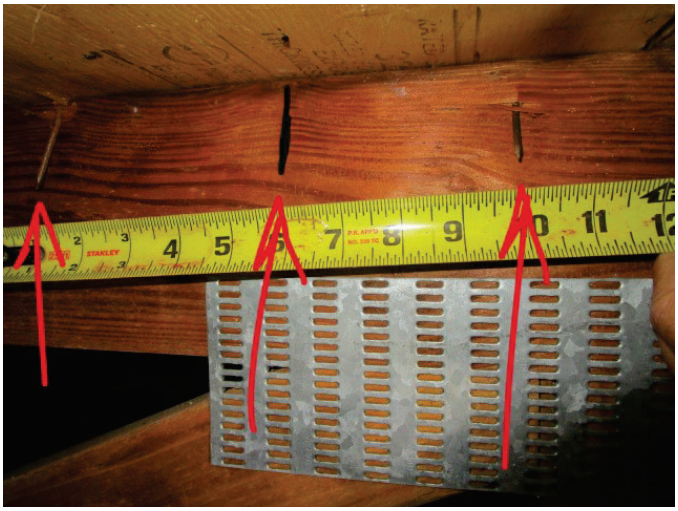
8d Nail

roof to wall attachment: hurricane clips

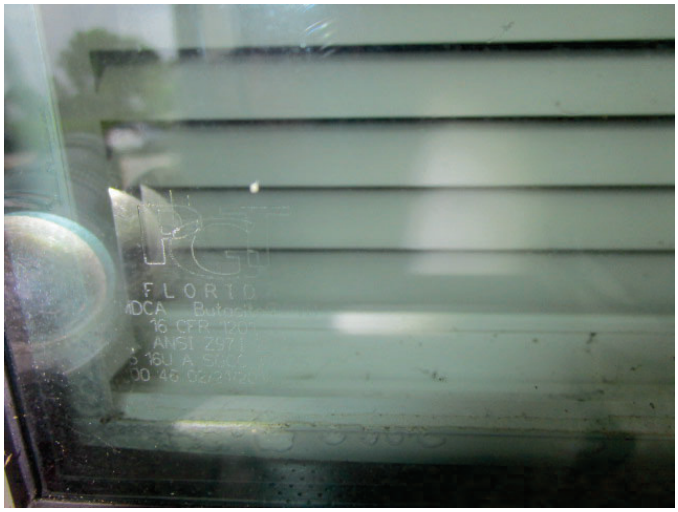
All windows appear to be impact rated
HOWEVER- some rear sliders are not impact
-some units have roll down shutters

impact windows mfg watermark MDCA=mia-dade county

non impact rear sliders

some sliders have roll down shutters
